**McClure Log House**  
**(Fallbrook Conservation Area)**  
**Heritage Investigation Report**

**14513 – 27 Side Road**  
**Concession 9, Lot 28**  
**Esquesing Township**

**Prepared by: T.Murison**  
**COPYRIGHT**  
**May 12, 2008**

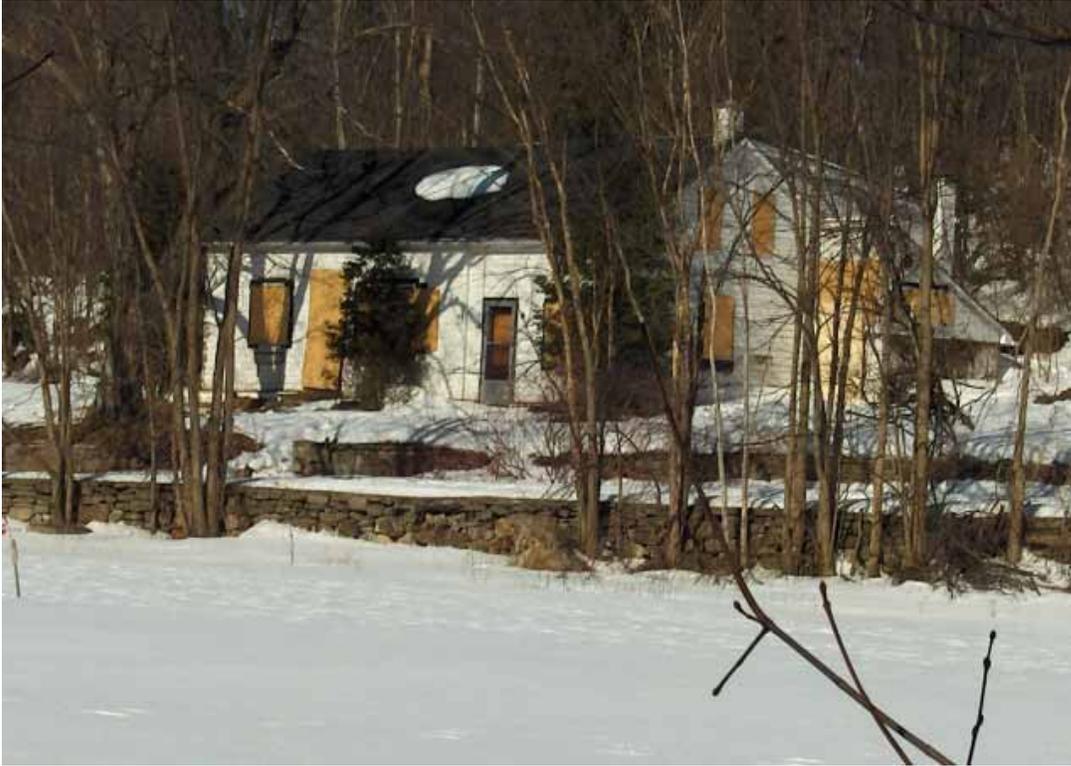
**South Elevation of House (03/08) Oldest part of house, log cabin, at the left, with frame addition visible, (door at center). Shed roof addition at rear (right side) is over masonry wall which retains hillside behind north side of house. The stone walls in the foreground were constructed in the twentieth century to elevate the laneway from the field.**

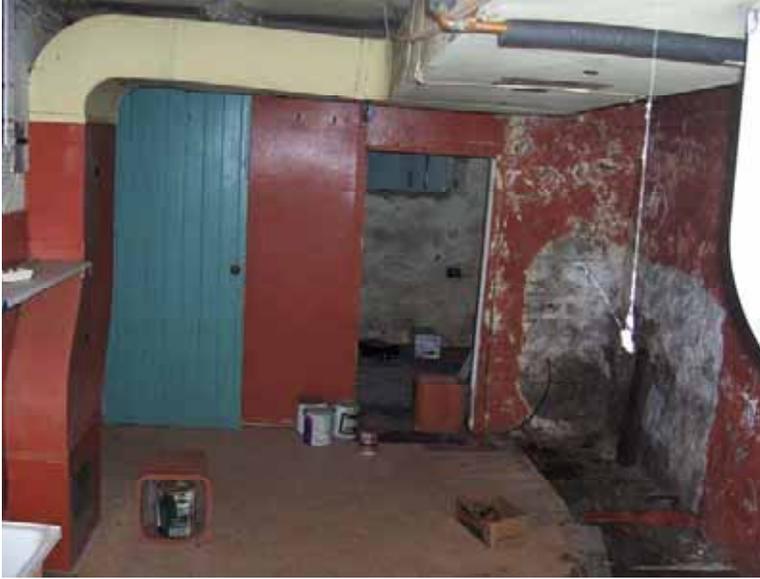
**1.14 View west inside the earth embanked, utility room** Blue door, left into kitchen. The stone wall (right side) is almost completely below grade. This stone addition may have been a very early addition to the house, constructed to deal with the chronic damp from snow and leaves against the north wall of the log house. In fact, the lower log course and exterior siding (just beyond the root cellar) was replaced by the C.V.C. approximately seven years ago. The slope of the hillside towards the house and the damp conditions on this north west corner have probably been of concern since the house was first built.

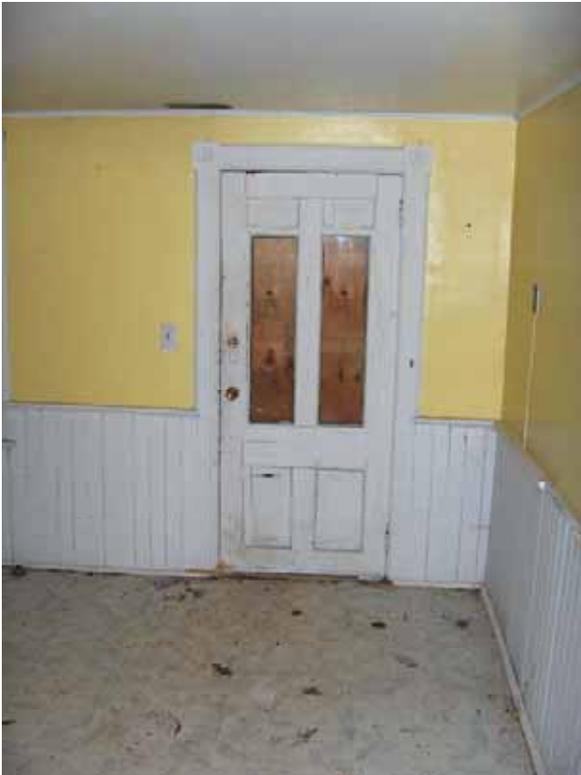
**1.15 Kitchen door /South Elevation.** Note tongue and groove wainscot with simple bullnose chair rail at 33” above floor. The plaster and lathe were installed after the chair rail and were finished onto the top of the rail, ensuring a solid and durable finish. This means that the rail and wainscot are about 7/8” thicker than more modern versions of this detail. In modern wainscot the boards are usually installed over the plaster wall. This is very similar to kitchens dating from 1830 to 1850, (Stewart house c.1835, Boston Church Road Milton), Simpson House c.1826, Milton. The machine made trim with turned corner roundelles is typical of houses c. 1865-85. These roundelles have a simple profile that varies slightly from block to block. This also suggests an early date of manufacture in a moulding shop, (even though they were made with a rotary cutter driven by machinery).. The deep linear profile of the trim at the head and jambs of the door were made on a stationary shaper. Water and wind power were replaced by steam engines as the motive power for factories, almost as soon as they were available (1840’s and ‘50’s).

1.16 The six panel door has been modified to accommodate two window panes. The modification was done very poorly, leaving almost none of the upper style and requiring filler pieces on the sides of the heavy plate glass to fit the rails. The door also appears to be cut down on the bottom rail, perhaps indicating that the floor is higher than originally constructed. This may mean that at least one more layer of floor boards were added above the original pine flooring. The ceiling is also a little too smooth for a plaster ceiling of this age. It has either been repaired by a competent plasterer, or covered with drywall and refinished. Adding finish over the original ceiling might explain the narrow gap between top of the door trim and the ceiling.

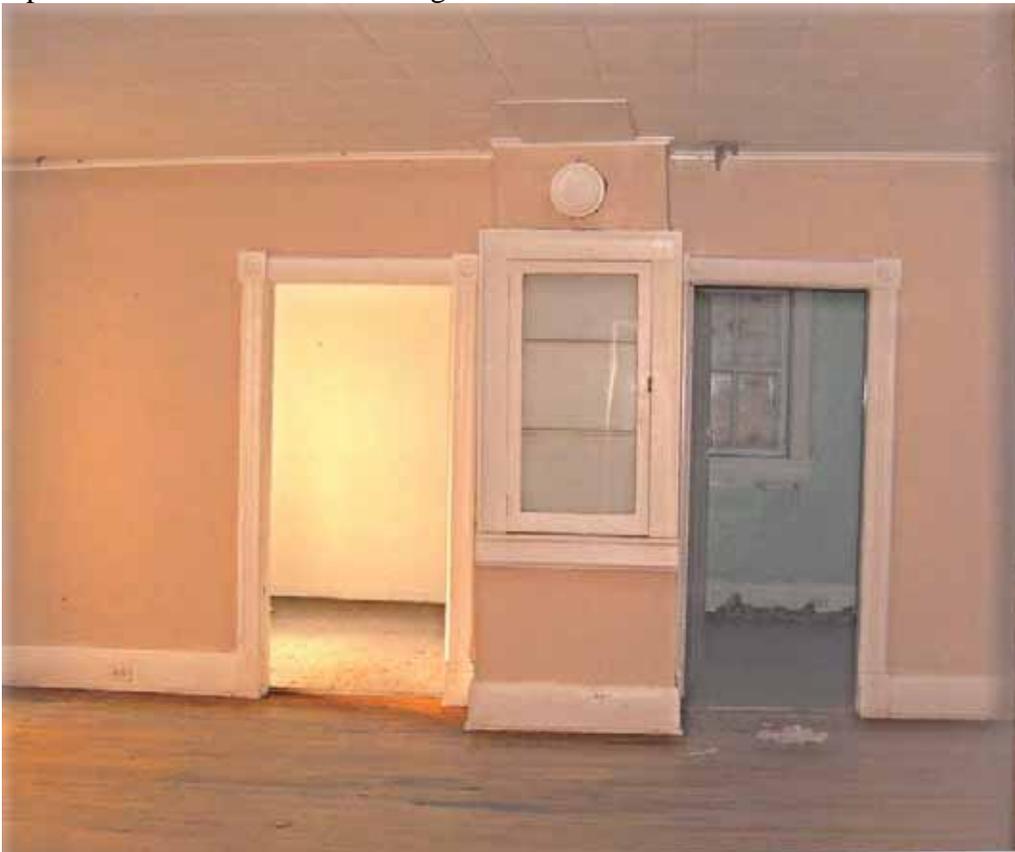
**Interior of log house looking west. © T.Murison 2008**

**1.17 View West** through the main room (formerly kitchen) into two small bedrooms on the south-west elevation. Note the masonry chimney stack hidden behind cupboard. The door in the cupboard has a single piece of glass typical of mid twentieth century so is probably a reproduction cabinet. The moulding around the frame appears to be similar to 1850's trim, but if it were an original construction, one would expect to find a beaded edge to the door opening, and a chamfered joint where the beads joined at the top and sides of this opening. The wood stool under the door is similar to original details. This cupboard appears to be a modern intervention in the design of the room, probably intended to cover the unused masonry flue, and provide a little storage space.

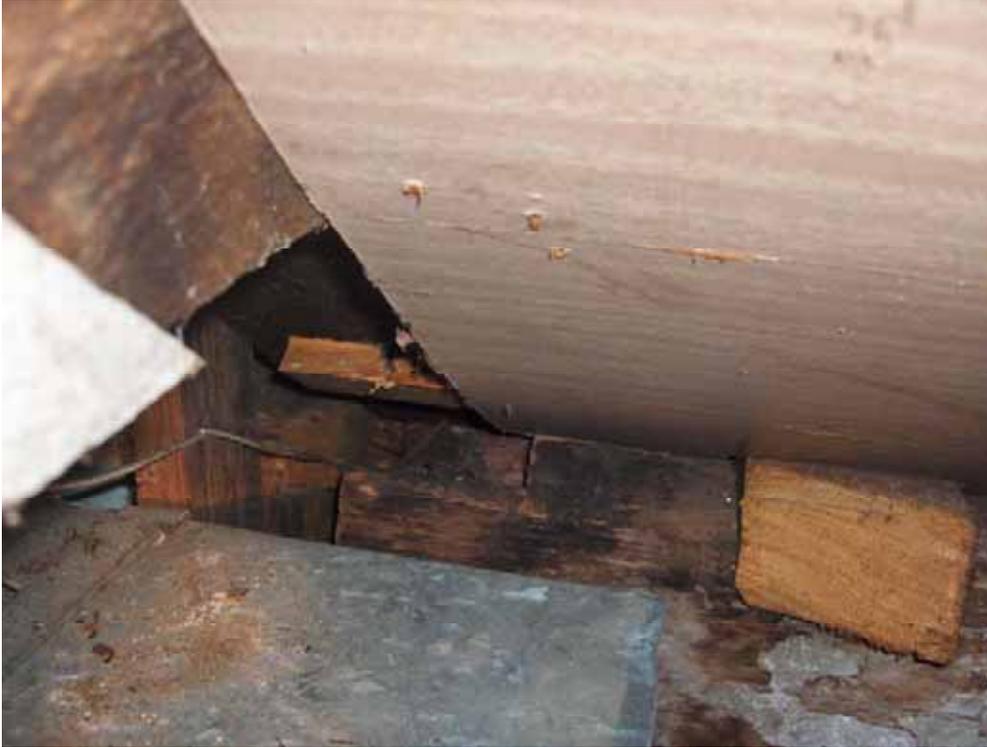
**1.29 Timber top plate** with portion of sawn top plate from adjoining addition visible under paneling (just below end of 1" sheathing that has been sawn off. Note also, the notch in the 8" log forming the top plate to support the rafters, and the sawn 3" x 4" piece that may have been used as a girt or tie beam for the log gable. The rafter tails were birdsmouthed in the typical way, but were stepped more than 5" into the log requiring a deep notch. It was more typical for the birdsmouth to be seated on a 1" notch chopped into the inner face of the log with a hatchet or broad axe. This method of roof construction and shallow pitch (approximately 5/12 are typical of the 1830-50 period. The sawn off 3" x 4" pine girt is a novelty however. The purpose of this piece is probably as a tie between the top plates across the house. Removal of the ceiling would be necessary to see if it has a dovetail connection to the timber, but it seemed to be installed tightly into the plate.

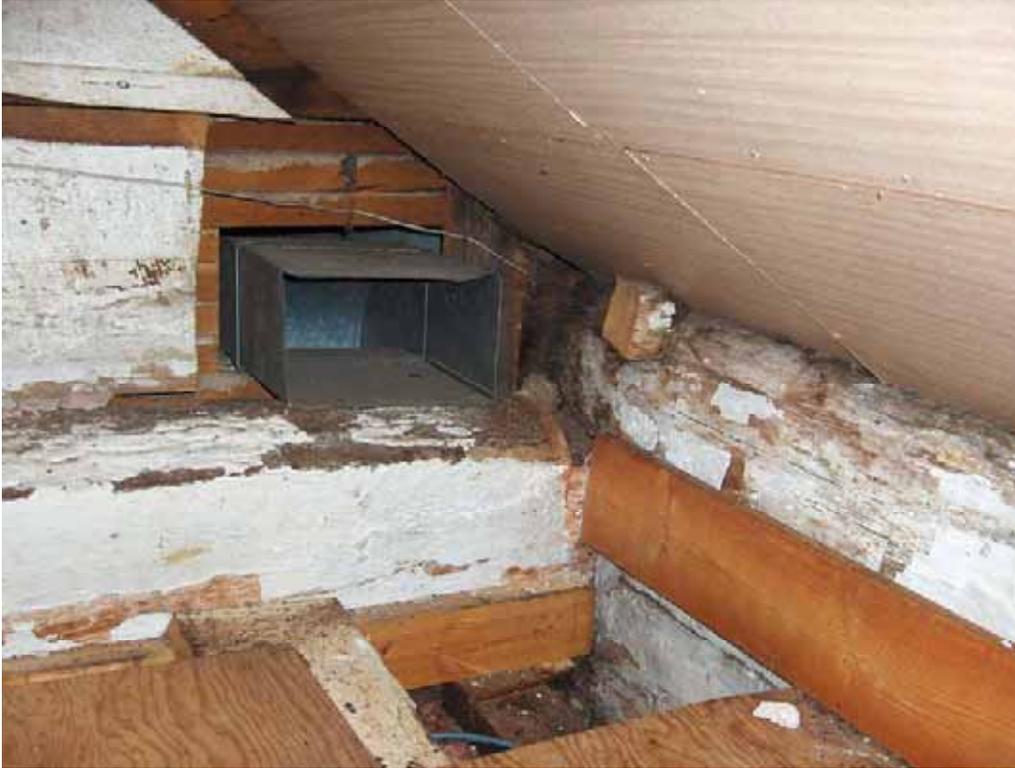
**1.42 Interior of McClure/McKay Log House, at top plate. Notice whitewash on logs and interior of gable frame wall. (Pine board on the right side and plywood flooring are modern). The whitewash flakes off in thick chips with visible layers indicating several applications of the mixture, applied over many years of use. © T.Murison 2008**

1.43 The presence of whitewash applied to all the attic surfaces, indicates that this space was in use as habitable space, probably as a bedroom. The bark is also visible on the log just below the modern duct. Sawn lathe and plaster is also visible behind the duct where the frame addition was constructed on the east side of the building. The bark is deeply furrowed and bonded tightly to the wood even now, an indication that it is extremely well preserved and red pine, not white pine. There is an indication of rotation of the top log on the right side of the image (south wall) probably due to the fact that the rafter seats are not transferring load from the birdsmouth joints (at the bottom of the rafters) to the inside face of the log, but beyond the midline of the log wall. Loading the log towards the outside face causes outward rotation of the top of the log, and usually distortion or failure of the wall. The fact that the log wall has not failed strongly suggests that the top log is pegged. Further evidence of this was noted where the half-dovetail was used on the top log of the west wall to attempt to lock it in place with the penultimate log on the south wall. This is an unusual error that suggests a builder with limited experience or understanding of the structural details of this construction.

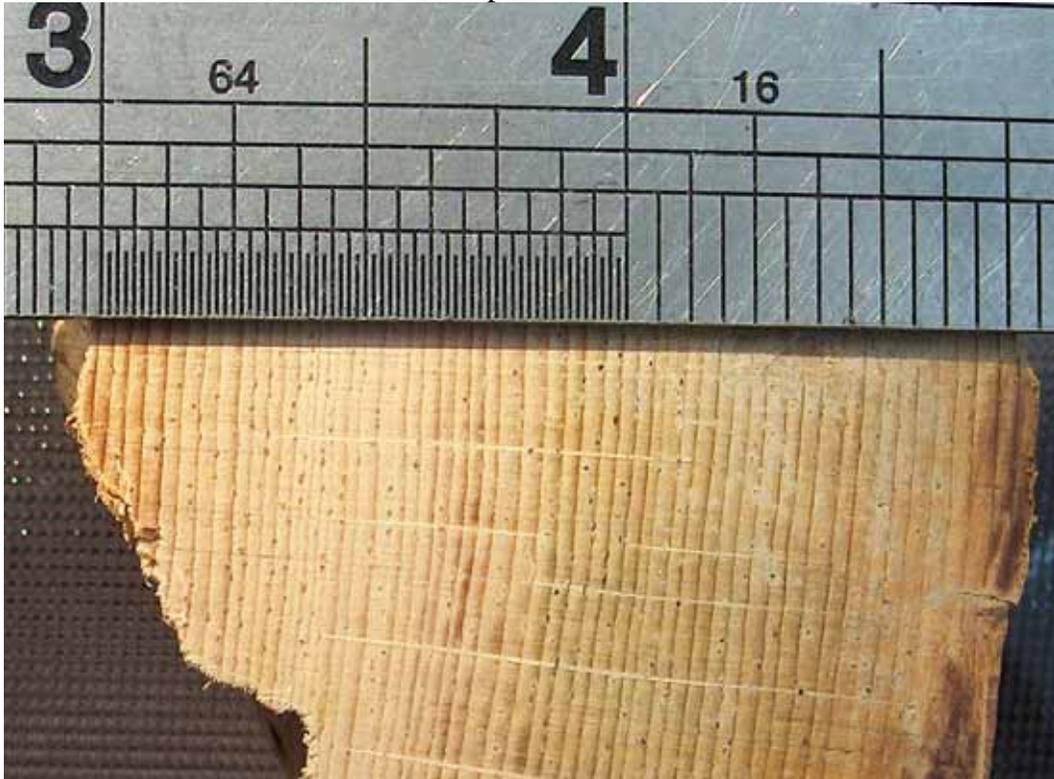
2.03 Sample 01 – Fallbrook– McClureHouse, Top Plate © T.Murison 2008

Note: Log exterior at right side, wood older towards left side, the interior of the tree. Species, Red Pine, *Pinus resinosa*, with clear rays and resin pockets interspersed in the annual rings. The best graph of the 40 year series for this sample is as follows:

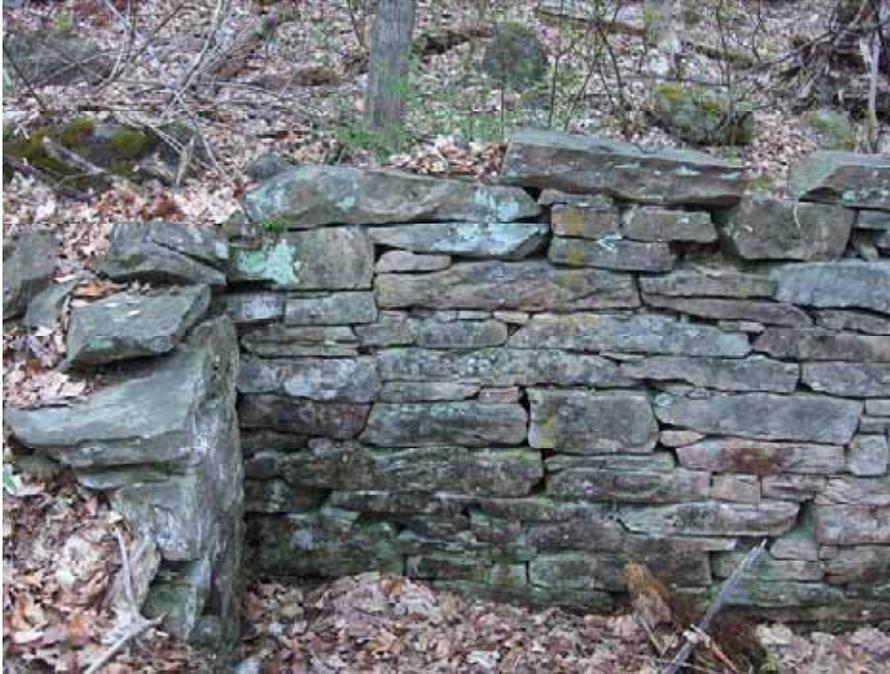
**4.16 N.E. corner of stone foundation for mill wheel. Upstream end wall at left.**

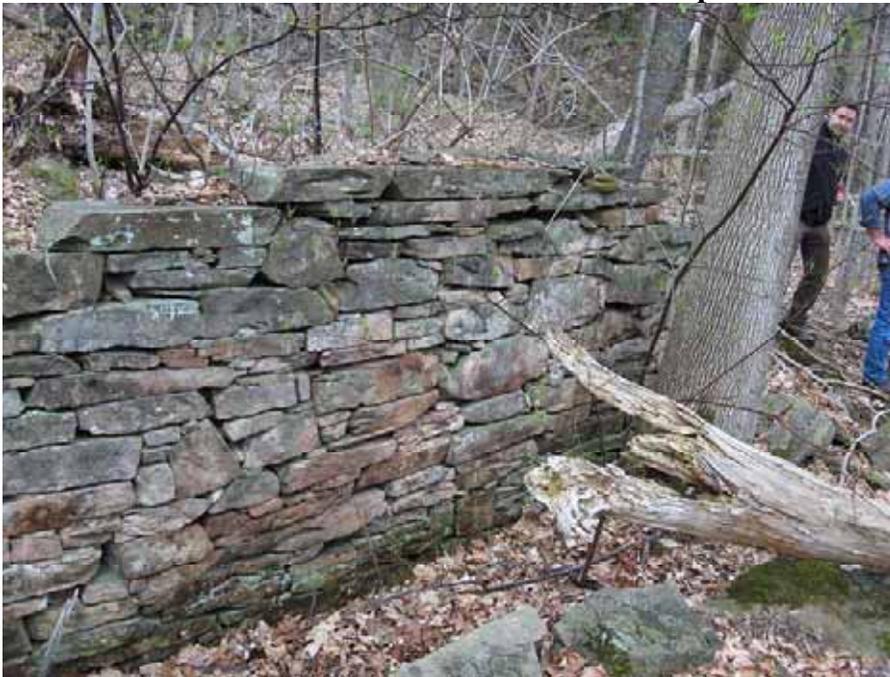
**4.17 Portion of earth embanked wall which supported bearing blocks for millwheel. Large (20") hardwood tree has grown up on the debris and stone which has filled the trench. Rob Kier (black jacket in background) a resident of the house, found these walls in 1961.**

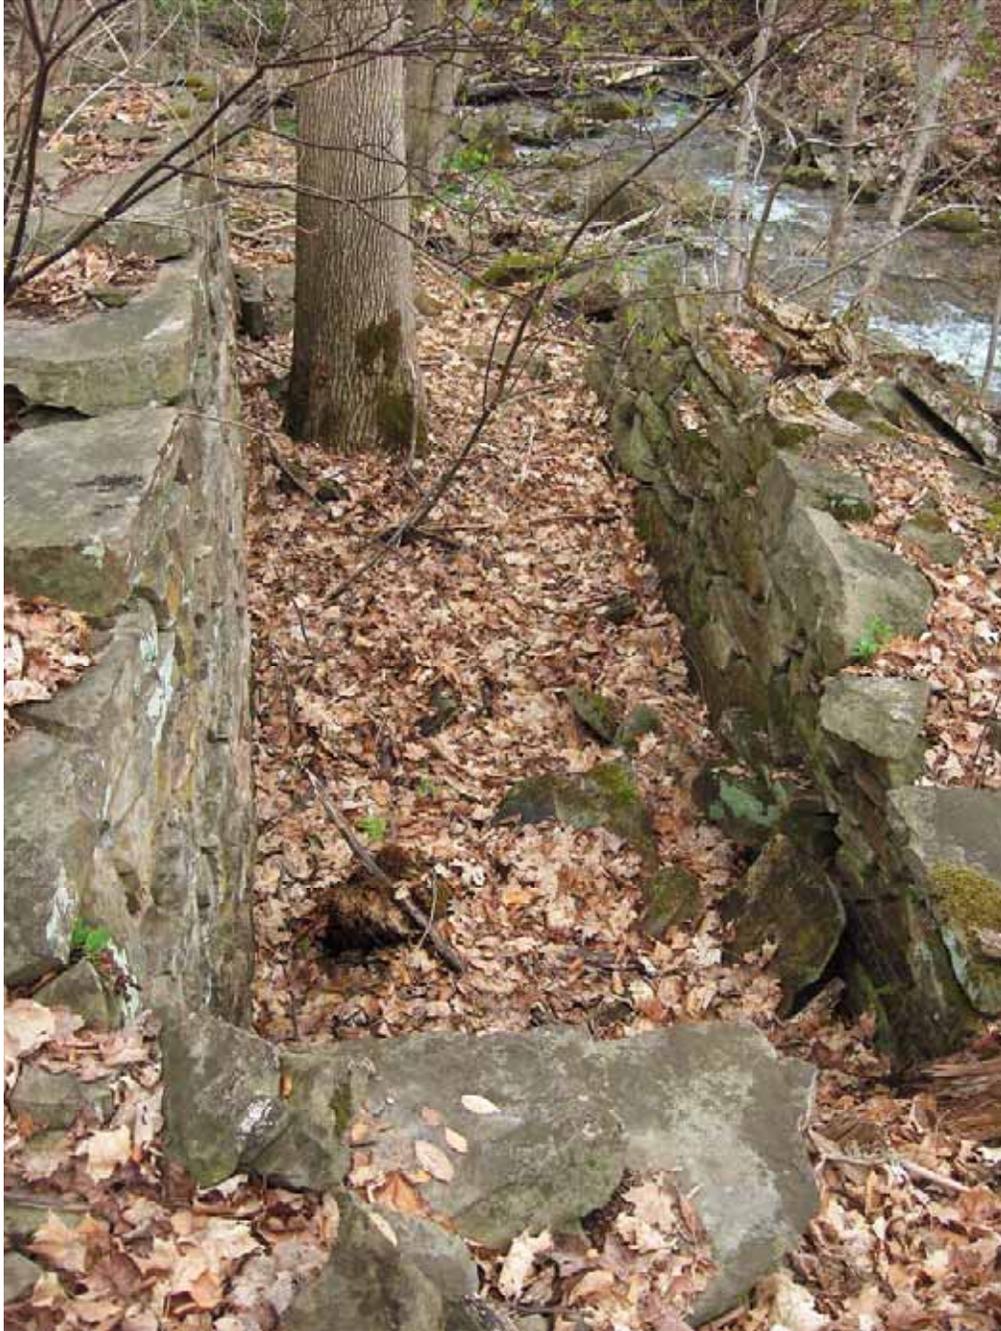
**4.18 View down into wheel pit. The west wall of the stone foundation has suffered more outward collapse, possibly due to floodwaters from the creek. It is believed to have been the same height as the east wall, so that the axle for the millwheel could be supported by both walls. The pit may extend several feet below the level of the leaves, which would create enough height for an overshoot wheel at least 14 feet in diameter and 4 feet wide. This is a large wheel which could provide approximately 25 horsepower to run a grist mill. The area to the east of the wall has several large stones that appear to be placed and leveled to carry the timbers which supported the timber framed mill building.**

4.23 \*\* Note, the stone foundation is filled with an indeterminate amount of stone rubble, leaves, soil and a large tree. Currently it is about 7 feet above the level of the creek, but the original floor of the wheel box may have been several feet lower. A couple of large fallen stones near the south end of the walls indicate that a wall on this side may also have collapsed both into and out of the wheel box. These stones may have to be removed to determine the original elevation of the outflow, and it could be closer to the level of the creek. This means that a sluice which was optimized for elevation would still provide nearly 25 feet of head to the overshot wheel, unless there was a concern about elevating the sluice over the roadway. If the sluice started at an elevation below the top of the road, another 7 feet would have to be subtracted from the overall height, further reducing head for the wheel to around 18 feet. While this would be considered substantial in many locations, it might not fit with the miller's concept of how to best use the water power at this location, which raises the question about whether the sluice started at the threshold of the millrace and ran over the roadway just east of the bridge. The road still takes a small dip on the inside curve at this point, so it is not hard to visualize the sluice passing approximately 8 feet over the roadway, with drops of cold water falling into puddles where teams would wish to take a drink as they pulled their wagon on a hot summer day.

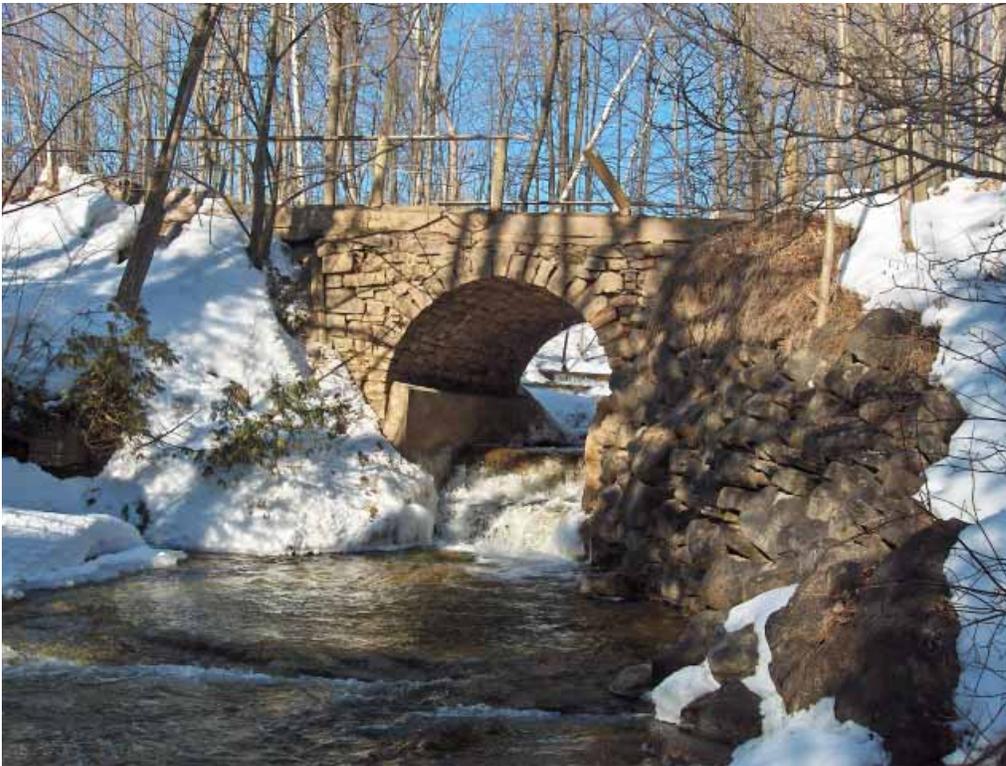
**5/06 Silver Creek Bridge (sandstone bedded in lime mortar, single vault) Note modern concrete abutments added to reinforce base of arch, and wooden railing installed on concrete cap laid over masonry. © T.Murison 2008**

5.07 This is a rare and beautiful example of a true masonry arch bridge. The bridge is sound but should be examined to see if the original pointing needs to be replaced. It has been repaired with concrete abutments at water level and along the edge of the road deck, probably after damage caused by a heavy flood which overtopped the bridge in 1952. A thunderstorm one night in July 1952, was reported by the Gates family to have caused the house to shake (100 metres away) as the flood water poured over the top of the bridge. It is believed that the parapets were destroyed by this storm because municipal workers subsequently repaired the bridge with concrete that is seen today.

5.08 The pressure treated post and cable railing is failing, so it is a perfect time to have the bridge repaired to the way it originally was. The gravel roadway is used by local traffic on No. 27 side road.

5.09 This is an important and rare rural bridge. It is due for maintenance and deserves to have the masonry parapet reconstructed to a level 3 feet above the road surface, in matching stone. This would require a skilled mason but would restore the bridge to a condition which is both authentic and functional.
