Subject: Heritage Impact Statement for Beecham House, 14513 27th Sideroad, Concession 9, Lot 28 Town of Halton Hills

Re: Heritage Impact Statement for 14513 27 Sideroad , Town of Halton Hills, **ONTARIO**

WOOD/McLURE/ O'HARA-VAUGHAN HOUSE (BEECHAM HOUSE)
14513 27 Sideroad , Concession 9, Lot 28 , Town of Halton Hills

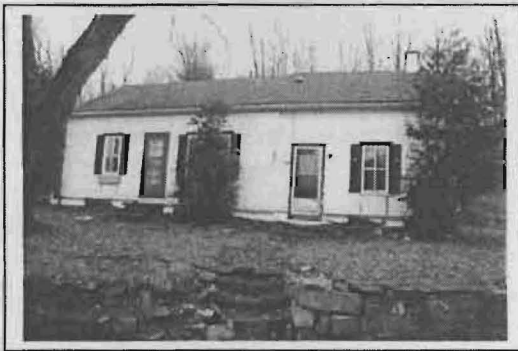
SOUTH ELEVATION (FRONT).

Front (south): The front façade seems to be unaltered and has well balanced original openings. Shutters have been added.

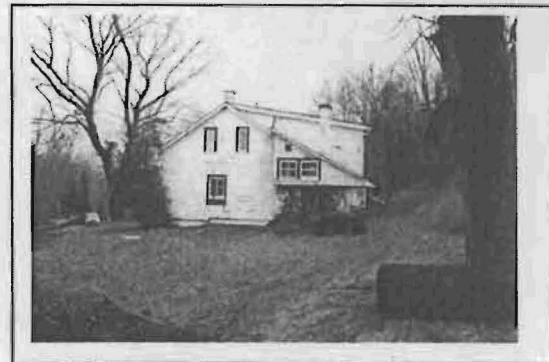
EAST ELEVATION

East wall: most of the openings appear to be original. The utility room windows are of an appropriate design.

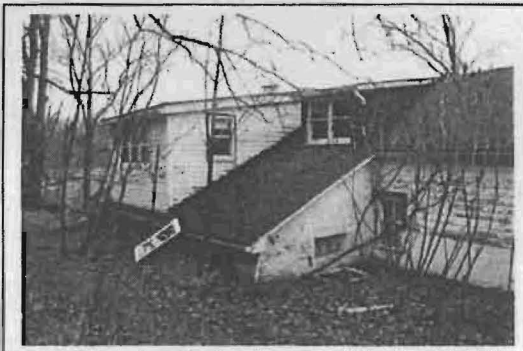
NORTH ELEVATION (BACK)

North wall: The cold cellar abuts the original house close to a centred original window. An old dormer remains and a large new dormer has been added besides it.

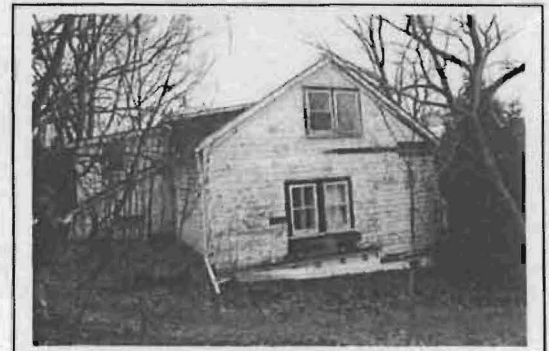
WEST ELEVATION

West wall: Details of this wall are plain and simple without boxed eaves. The openings appear to be original. The siding may be a later replacement over original strapping.

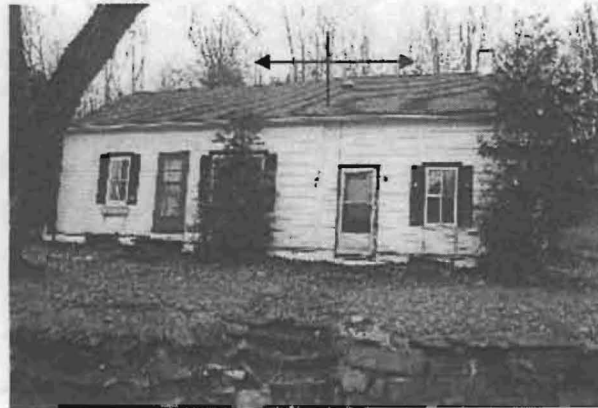
5. Front elevation showing two parts.

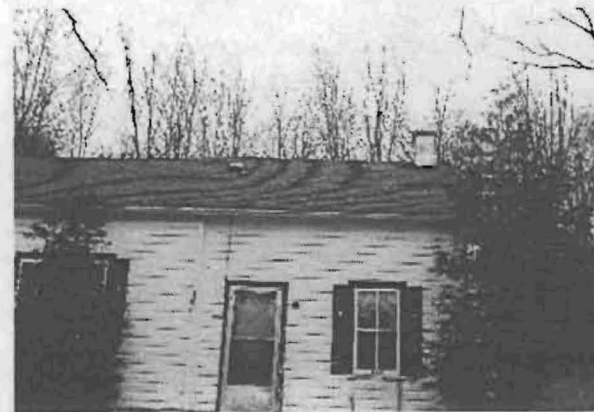
6. The join of the two parts. The east part is set back slightly.

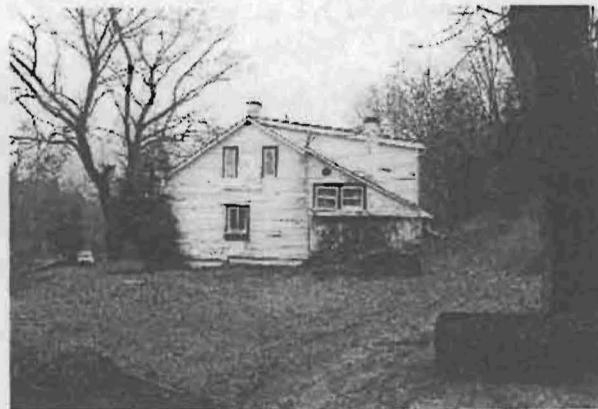
7. East elevation showing dormer and lower utility/
cold cellar area.

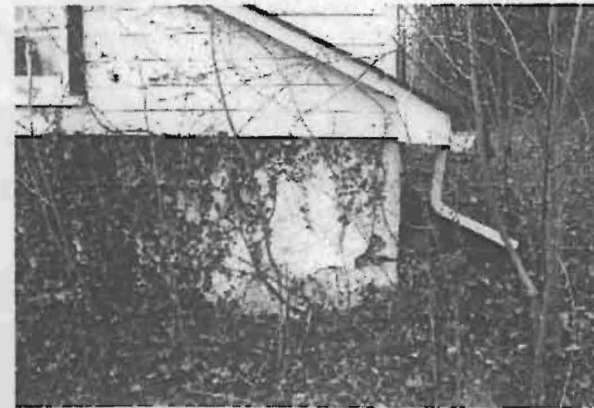
8. Close up of the utility/cold cellar wall. Plaster on
stone.

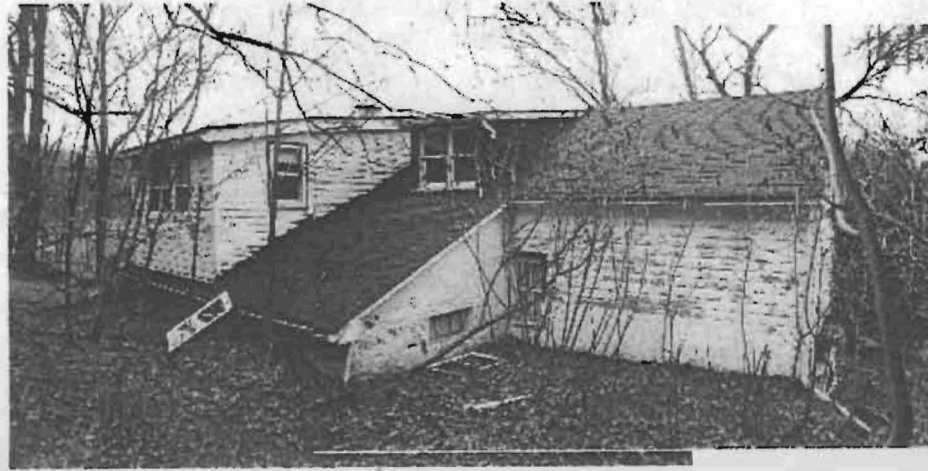
9. The back of the house is partly built into the hillside. The cold cellar is an early addition and the large dormer is probably somewhat later.

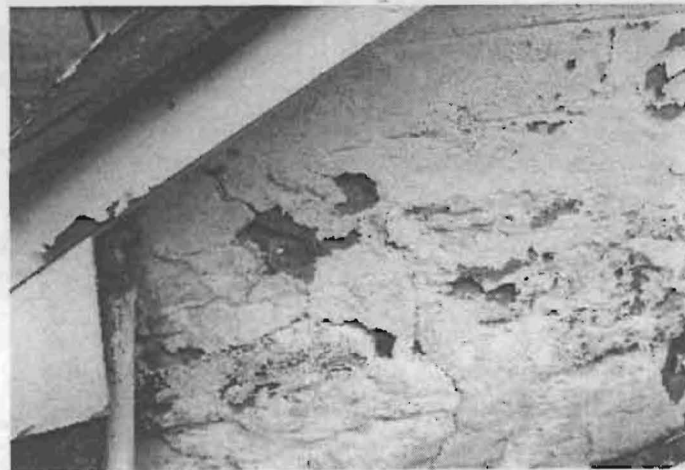
10. Close-up of the cold cellar wall showing a relatively thick layer of plaster over rubble stone. The plaster has a reddish colour indicating a local sand was used.

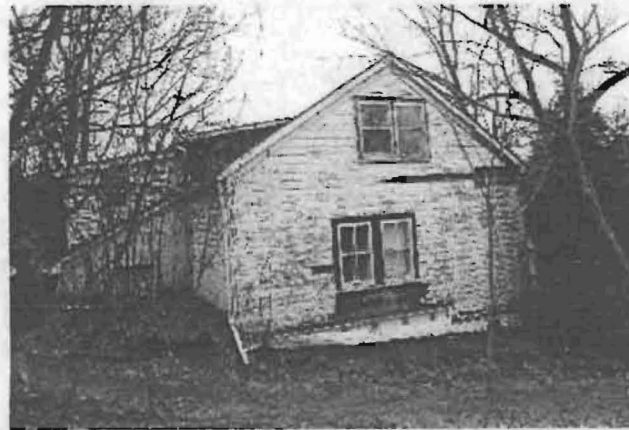
11. West wall. The upper window may be an addition.

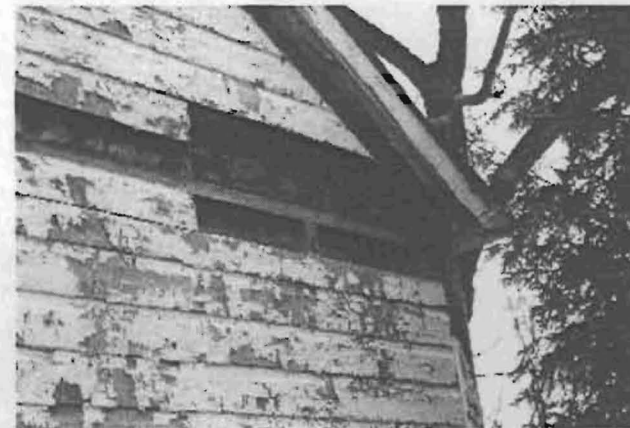
12. Damage at the eaves shows heavy applications of mortar and rubble. Logs are not clearly evident.

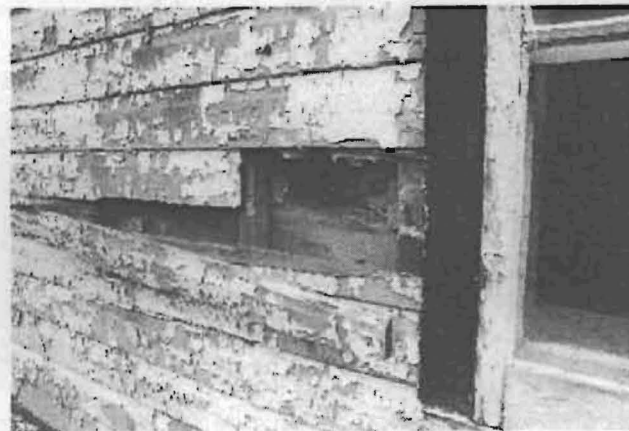
Mr. McGillivray notes in the Report that the structure is of squared log construction. However, wood strapping (to serve as siding) was added shortly after construction, potentially diminishing the heritage significance. Also, with the addition of the wood strapping, the condition of the log structure underneath is unknown.

13. The sawn log construction is clearly visible where the siding has been broken. The strapping is old wood indicating that the logs may have had siding added at an early date.

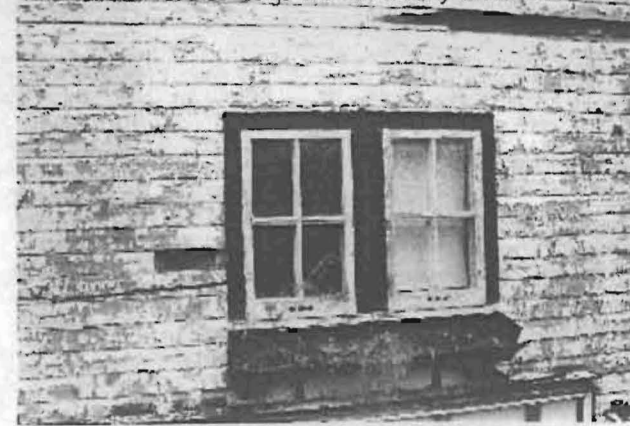
14. Close up of windows and hole in siding where photo 13 was taken.

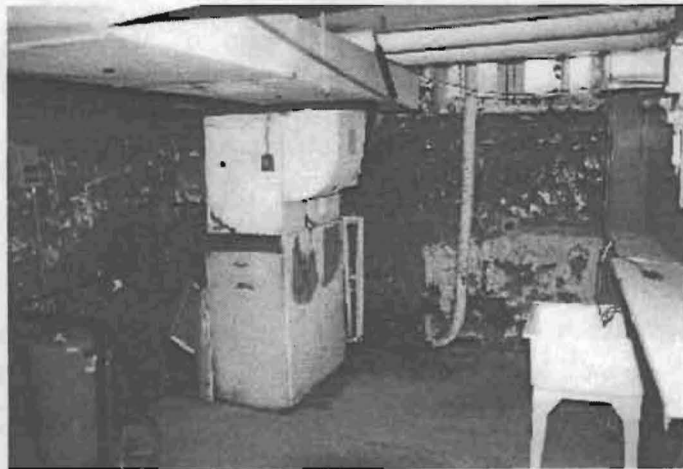
15. Back entrance and utility area.

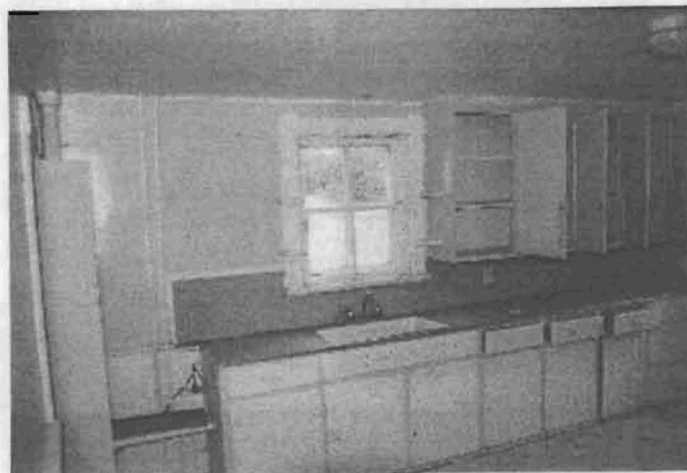
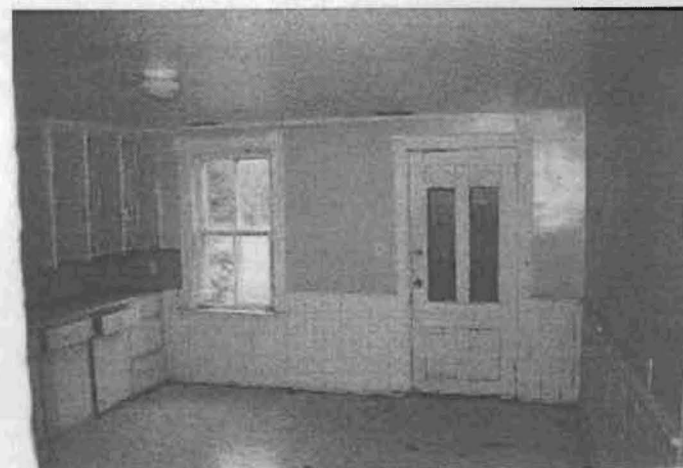
18 - 19. Two views of the Kitchen area (east end addition)

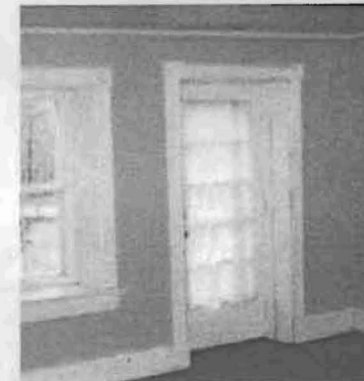
25. Detail showing thick walls at front door and window.

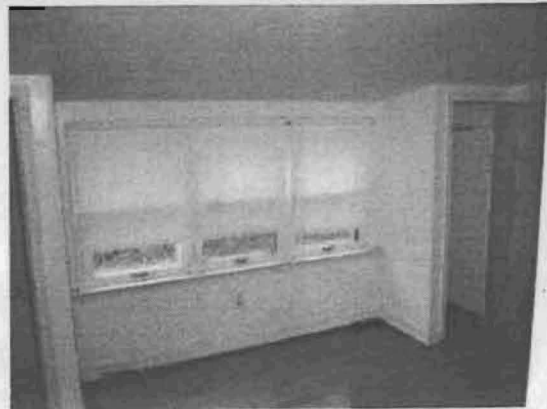
27. North dormer windows.
