**CULTURAL HERITAGE EVALUATION REPORT
HALTON HILLS CULVERT #54C**

**(LOT 28, CONCESSION 9
GEOGRAPHIC TOWNSHIP OF ESQUESING)
27TH SIDE ROAD
TOWN OF HALTON HILLS, ONTARIO**

CULTURAL HERITAGE EVALUATION REPORT

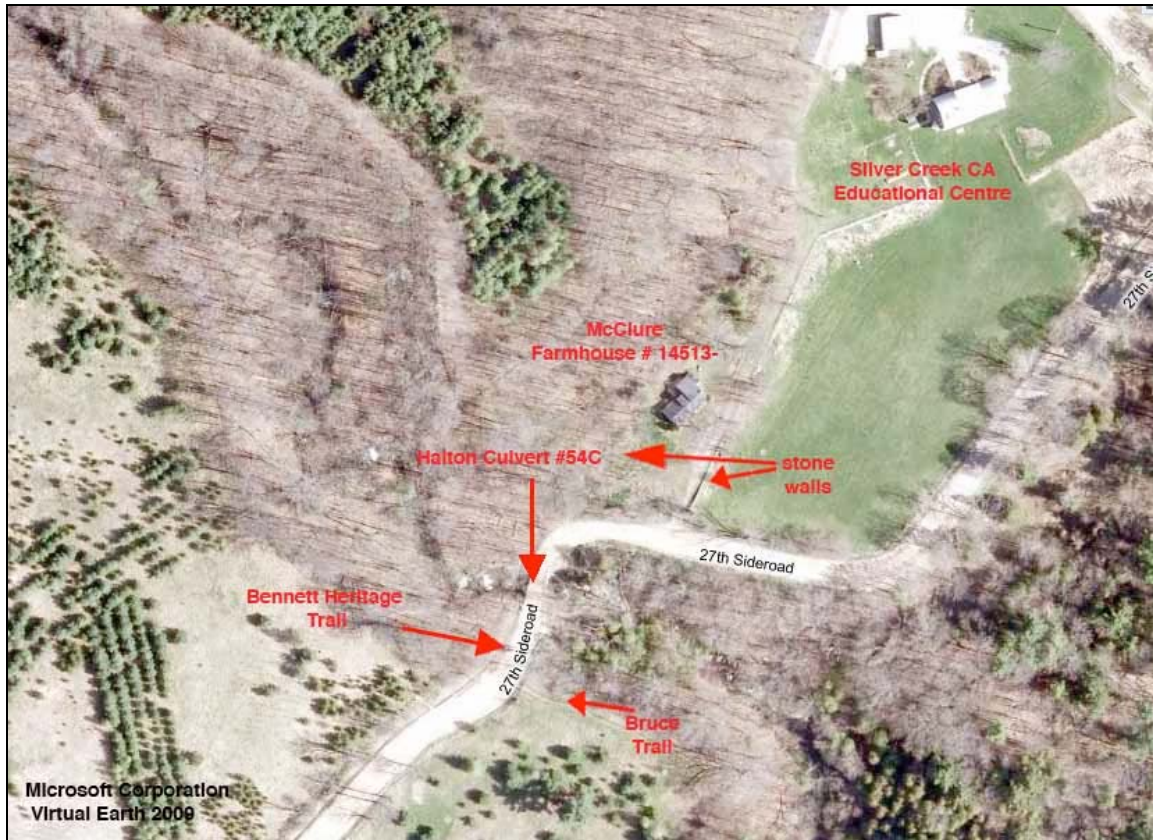
Figure 2. Aerial of the location of Halton Culvert #54 C [Microsoft Virtual Earth 2009 as adapted by Unterman McPhail Associates].

The Halton Culvert #54C spans a tributary of Silver Creek. The Silver Creek flows in a southerly direction in the northeast corner of Town of Halton Hills. In the vicinity of the bridge the stream flows from northeast to southwest. The banks of Silver Creek are steep and in a naturalized state with trees, vegetation and outcrops of limestone. The bed of the creek is limestone and it falls quickly to the south in the vicinity of the bridge crossing. Historically the creek was dammed with a millpond to the north of the bridge.

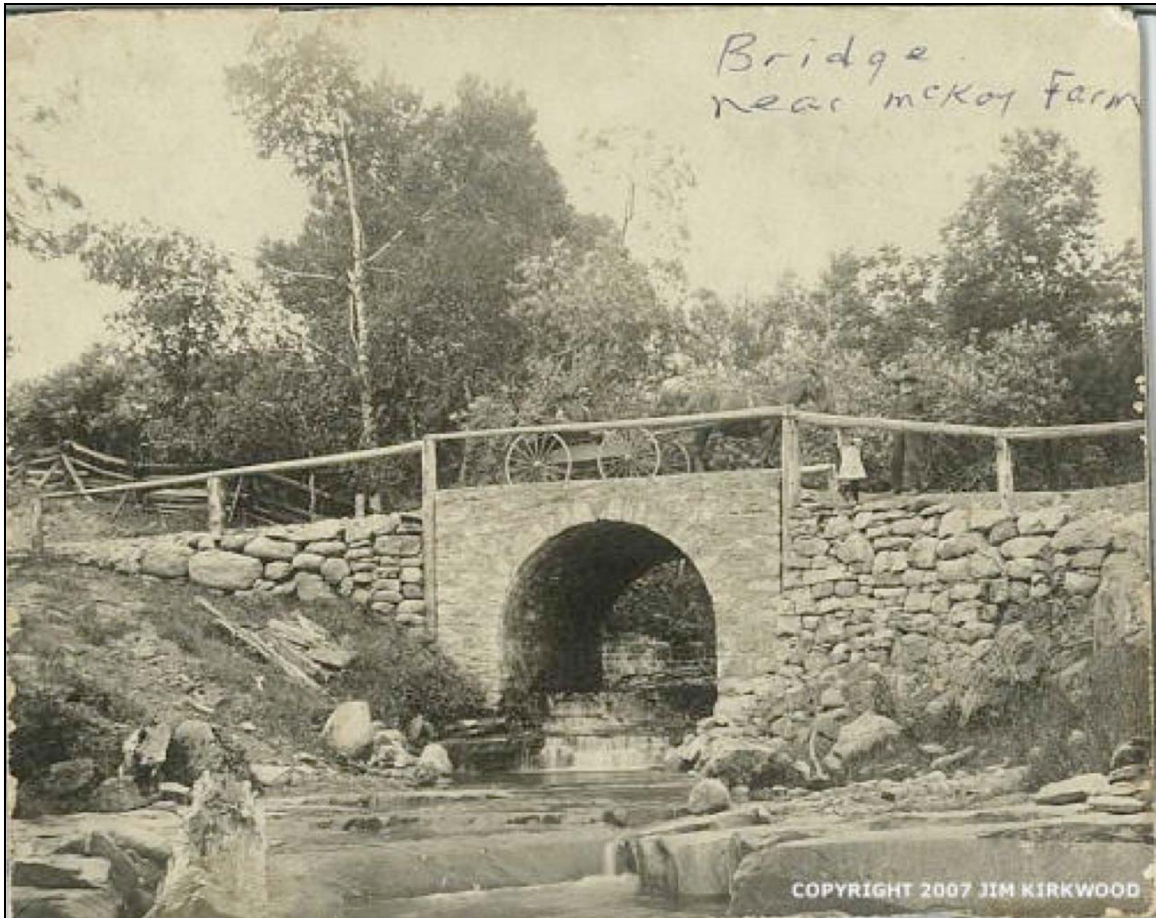
View of south elevation of the bridge c1921. Copyright Jim Kirkwood, courtesy of Fallbrook Campaign.

An historical photograph circa the early 1900s shows Donald McKay, Sandy McKay and grandchildren, Sandy and Rachel, on a single arch stone bridge over the Silver Creek (**Appendix A**). The bridge is shown with a radiating voussoir of stone, coursed stone abutments, and a wood had railing consisting of six wooden posts set at regular intervals with a wooden hand rail, but no intermediate posts.¹⁷ A recollection of the McKay family indicates there were no guardrails at one time in the early 20th century.¹⁸

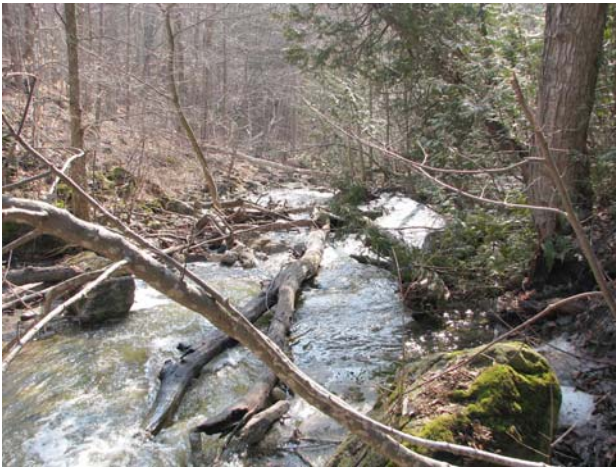
View downstream from bridge showing the spring flow of the creek and the natural vegetation and steep slope..

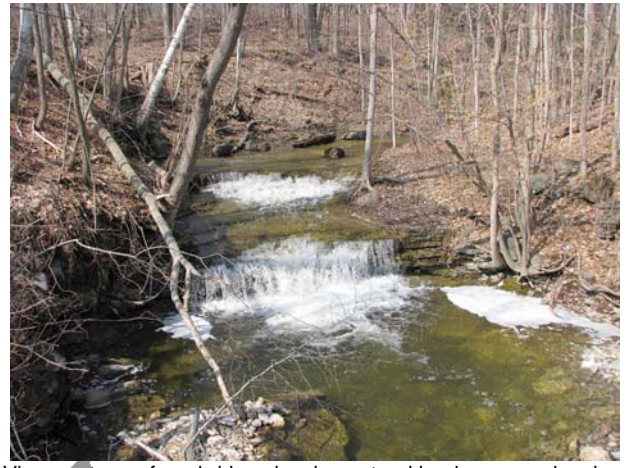
View upstream from bridge showing natural landscape and spring flow of the creek as it tumbles down the stepped limestone.

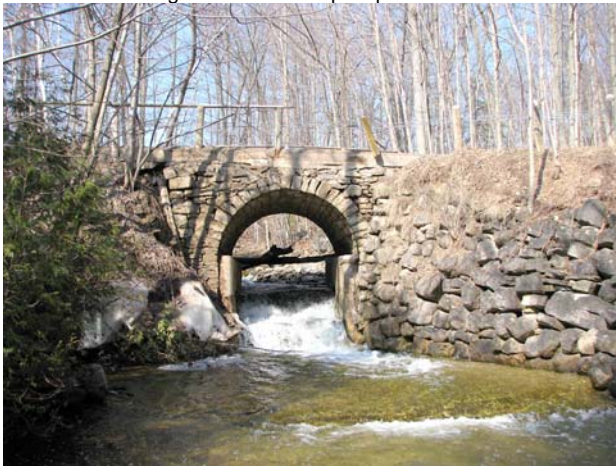
View north to south elevation (downstream).

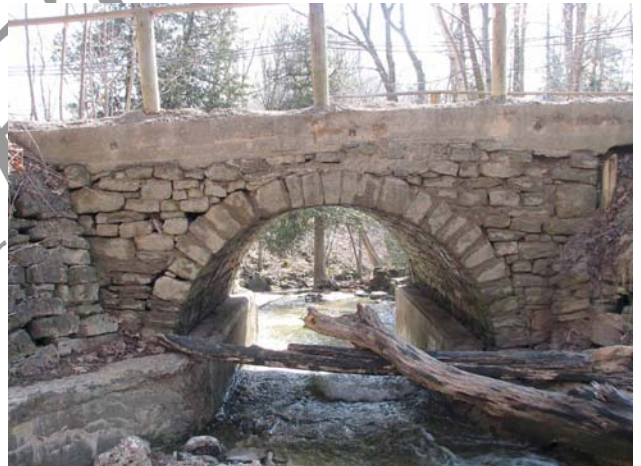
View south to north elevation.

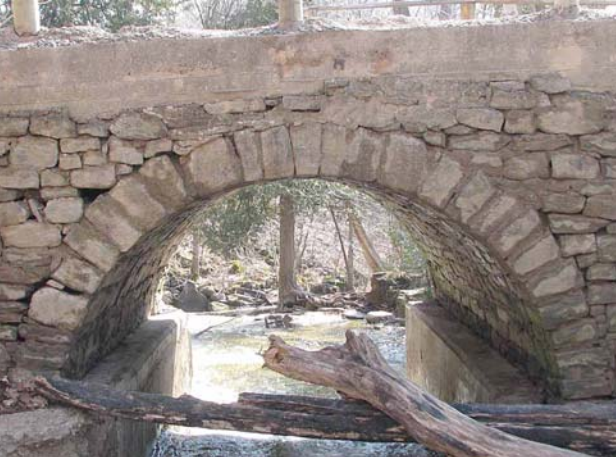
Stone arch of bridge upstream side..

The stone arch bridge is built in a functional manner in quarried limestone laid in courses with a vertical, voussoir of wedge shaped stones, particularly the keystone. The keystone is the most important stone in an arch bridge, and holds the arch together. The stones in the coursed walls and the voussoir are quarried with roughly squared edges.²⁵

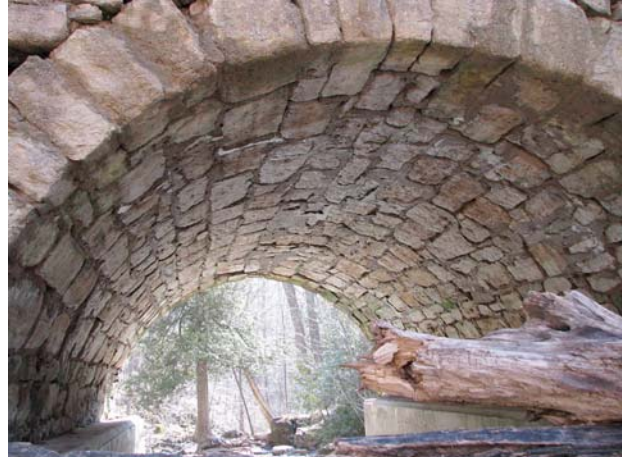
View southward to underside of the stone arch.

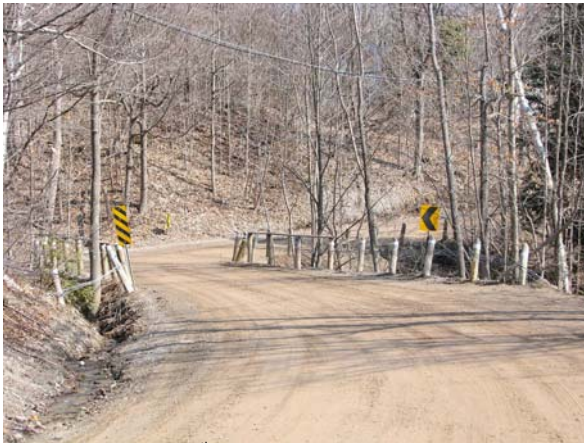
View easterly along 27th Side Road to bridge

The deck is a later addition of concrete with a gravel surface. There are no curbs. The railing system consists of ten (10) vertical wooden posts with three horizontal steel cables, total length of the railing system being measuring 9.2 m (30-ft. 2-in.). The railing system is failing in places and the road edge has eroded in certain locations. No sidewalks are provided on the bridge.

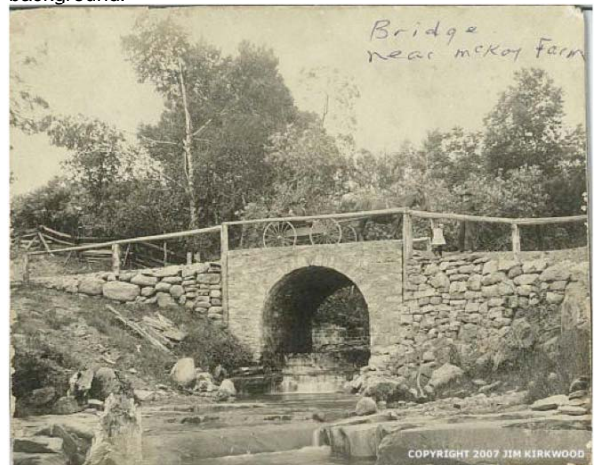
Photograph of the subject bridge over Silver Creek circa early 1900s [Copyright 2007, Jim Kirkwood, permission courtesy of Fallbrook Campaign].
