**McClure Log House**  
**(Fallbrook Conservation Area)**  
**Heritage Investigation Report**

**14513 – 27 Side Road**  
**Concession 9, Lot 28**  
**Esquesing Township**

**Prepared by: T.Murison**  
**COPYRIGHT**  
**May 12, 2008**

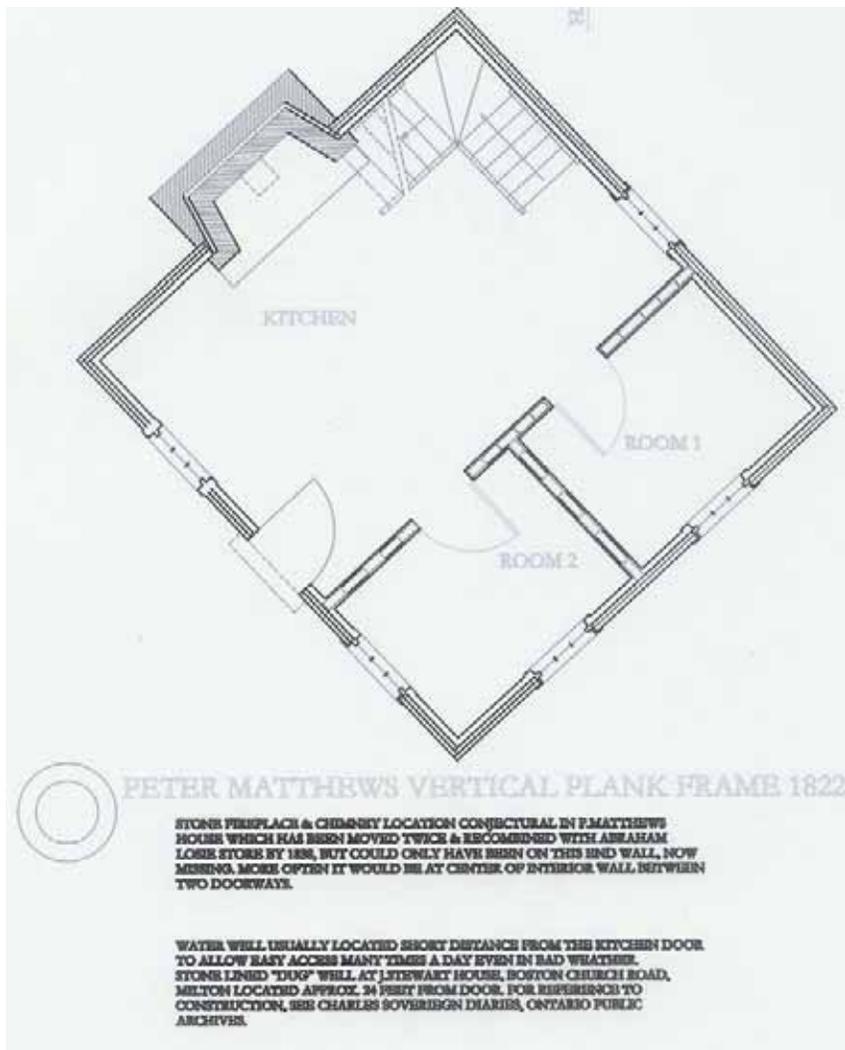
**1.20 PETER MATTHEWS HOUSE 1822: ORIENTATION (NORTH AT TOP) KITCHEN DOOR FACES SOUTH-WEST © T.Murison 2008**

**1.21** Even though this is a vertical plank frame building and not a log structure, the general dimensions and layout are similar to the subject building, with careful attention to orientation of the windows. This suggests that obtaining natural light was paramount in the builders mind and that the wall which faced into the prevailing winds in winter, was most often left blank at the ground floor. . The single window on the north-east elevation was changed to a door probably before 1845. The fireplace and stairs in the north wall was also removed as per notes. The cupboards stair was very steep and occupied as small a space as possible. It was usually enclosed with a board partition and batten door at the bottom. Closing this door would keep the ground floor rooms warmer in winter.

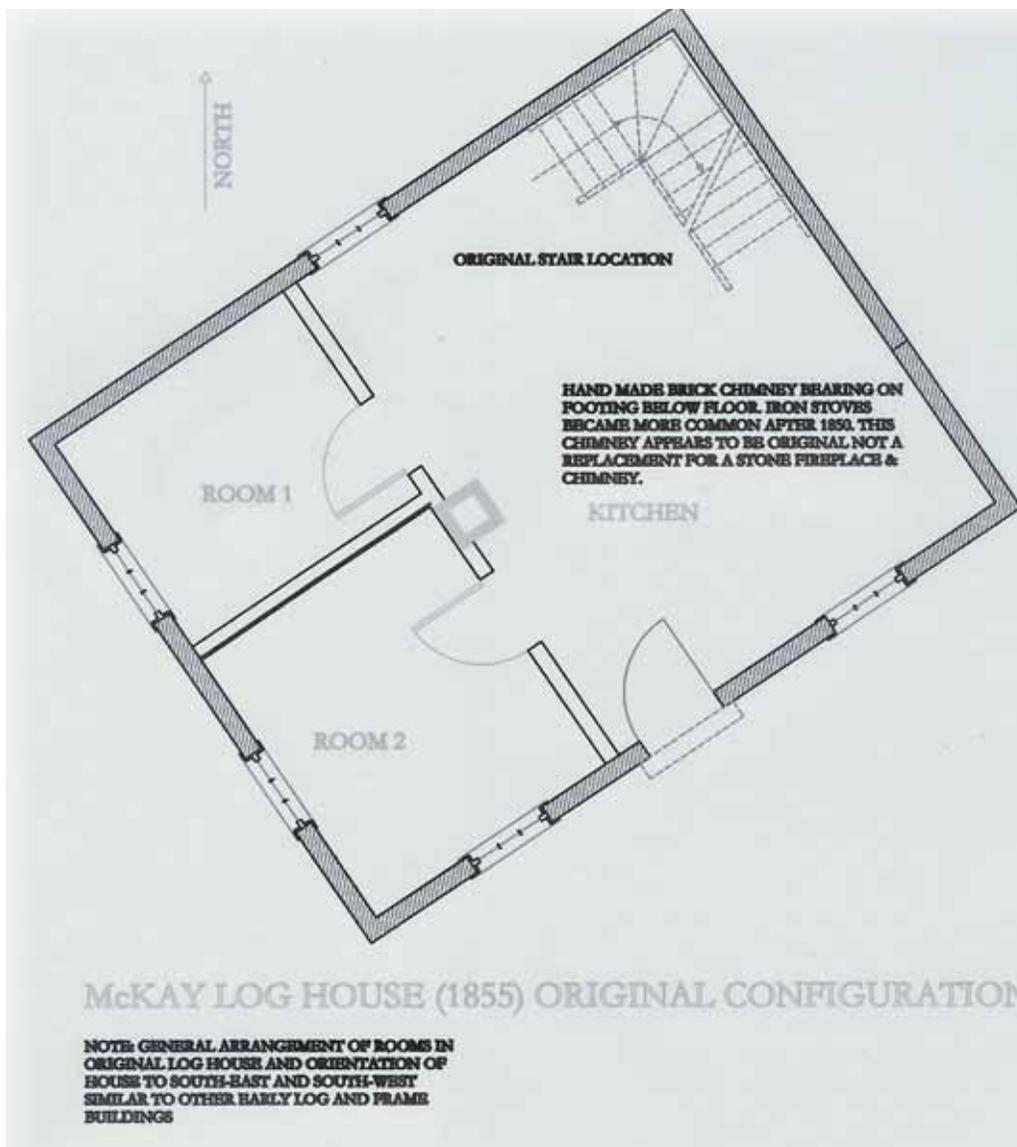
**1.22 FALLBROOK / McCLURE HOUSE (1855) NORTH IS TOP OF PAGE, KITCHEN DOOR FACES SOUTH-EAST. STAIR IS PROBABLY IN NORTH CORNER WHERE FLOOR PATCHED AFTER ADDITION. © T.Murison 2008**

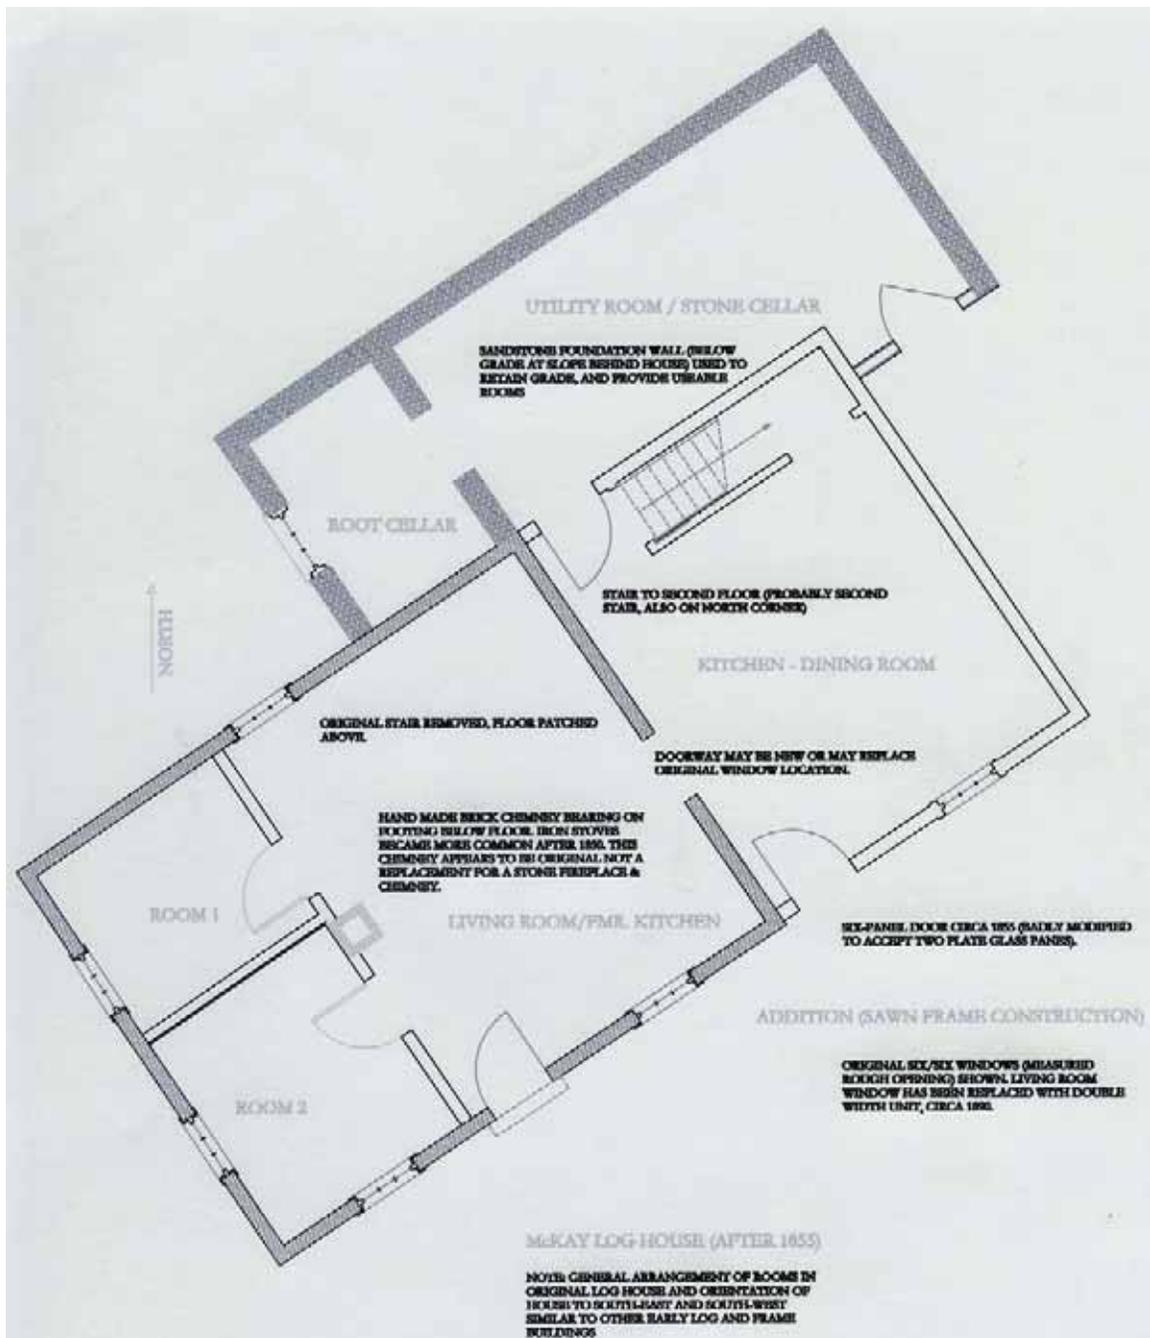
**1.23 FALLBROOK / McCLURE HOUSE (AFTER 1855)** Additions to the East (sawn frame) and North (rubble stone foundation wall to retain hillside). Stairs moved. This is similar to the current plan, except for minor changes (replacement of windows, kitchen cabinetry, etc..) © T.Murison 2008

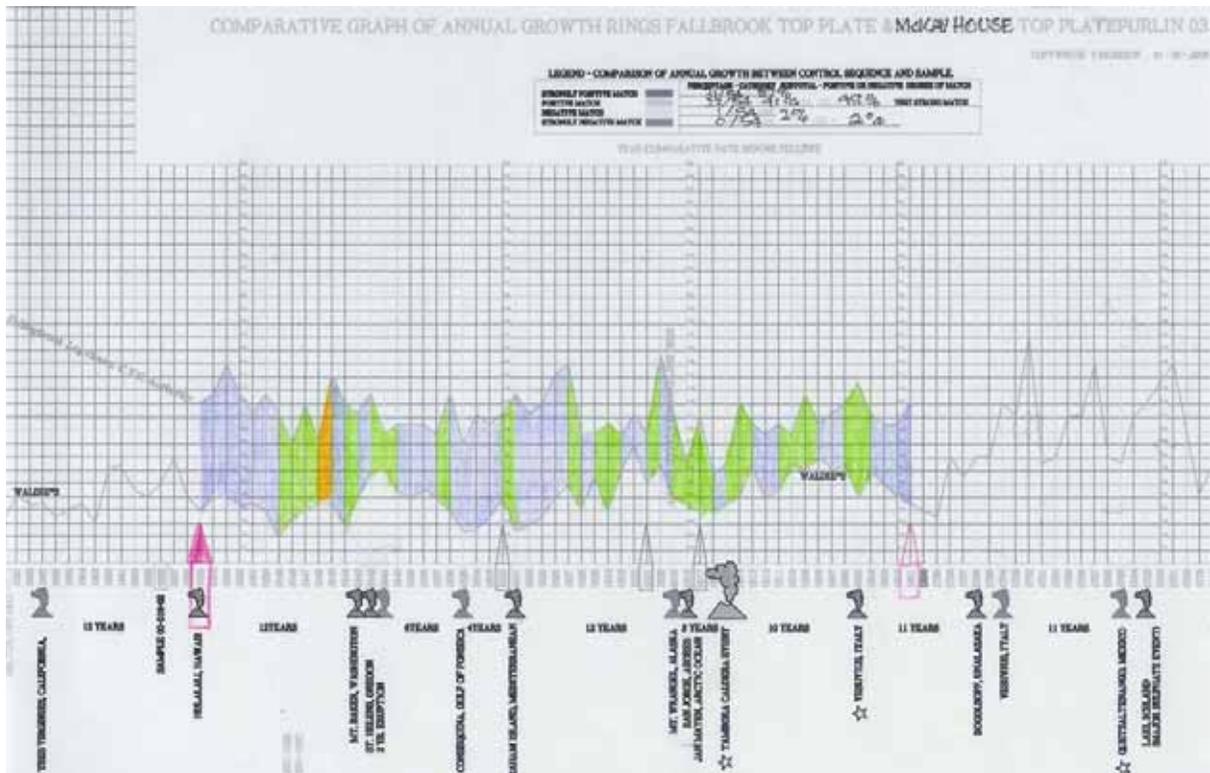
**2.04 Comparative Graph: Waldies Addition Top Plate & McClure House, 98% Positive Match for 1855 as last year of tree growth. Therefore construction of house 1856.**

Note, blue bars, indicates strongly positive matches for a given year, (less than 0.2 mm variation between the benchmark sample & the subject sample. Green a positive match, (0.2 and 0.4 mm.), yellow - negative match (0.4 to 0.6mm.) & red (none found in this sample) strongly negative (more than 0.6 mm. deviation from the benchmark. This graph has only one annual growth ring that varies more than 0.4 mm. (yellow) from the benchmark graph. It is a 98% positive match for 1855, the last year of growth.

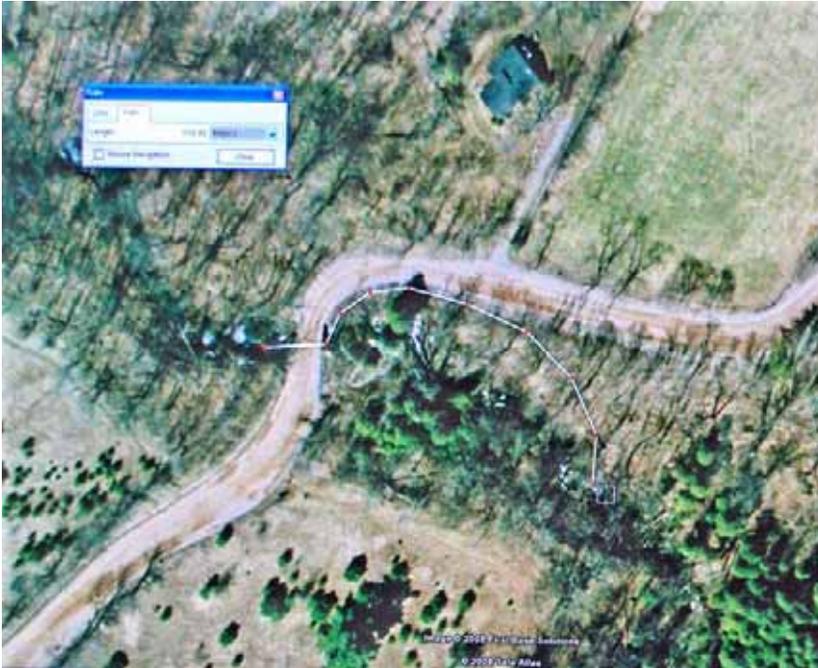
**4.26 Aerial Photo alternative (110 m.) alignment of sluice boxes (route not used)**

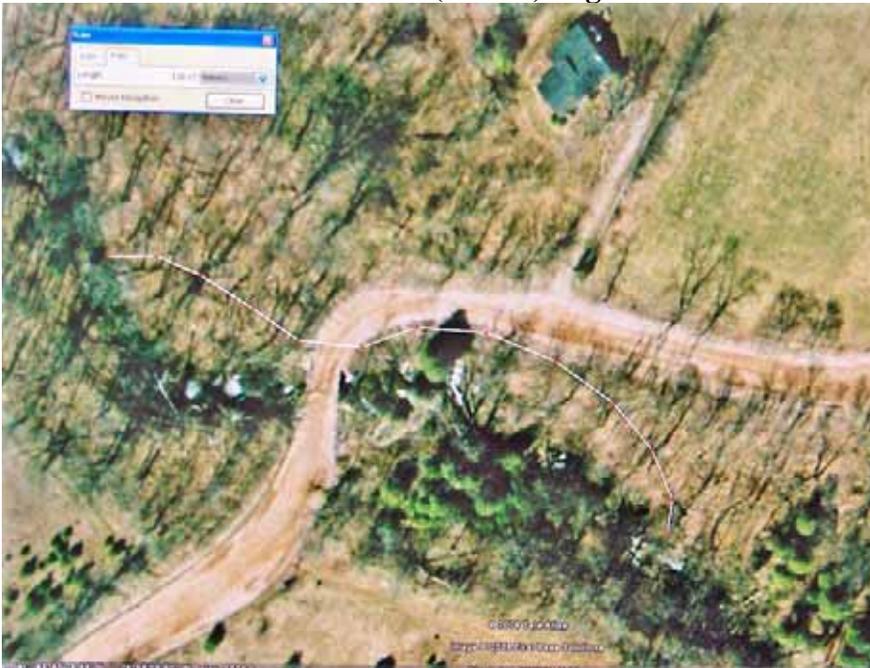
**4.27 Aerial Photo of the probable (130 m.) alignment of sluice boxes for the lower mill. The additional 20 metres of sluice would bring the same volume of water from almost 10 feet (3 metres) higher.**
